Direct repair of crown and bridge veneers

In the concluding part of his article series, **Markus Firla** discusses the intraoral repair of chipped ceramic or composite veneers covering fixed crowns and/or bridges

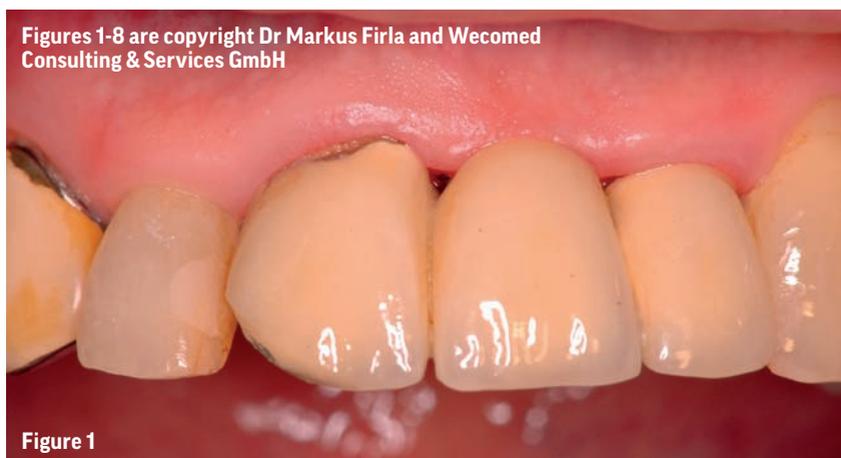
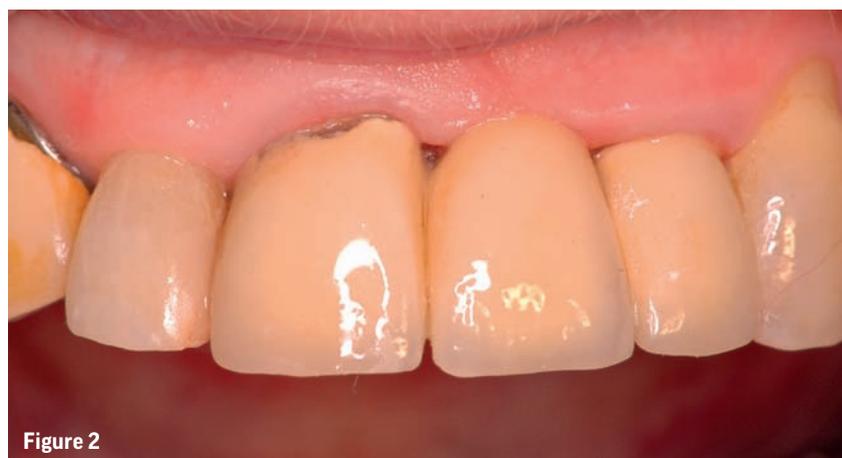
Figures 1 and 2: Before and after. The disto-incisal edge of the ceramic veneer of this crown on tooth UR1 was intraorally repaired, and the aesthetically insufficient mesio-buccal composite restoration in tooth UR2 was replaced. Thanks to the biomimetic shade and translucency characteristics of Beautifil II LS, the procedure was quick and easy, and the final result was excellent. Only one composite shade (Beautifil II LS A3) was needed to restore these two defects. And one composite increment each was sufficient to achieve the desired result

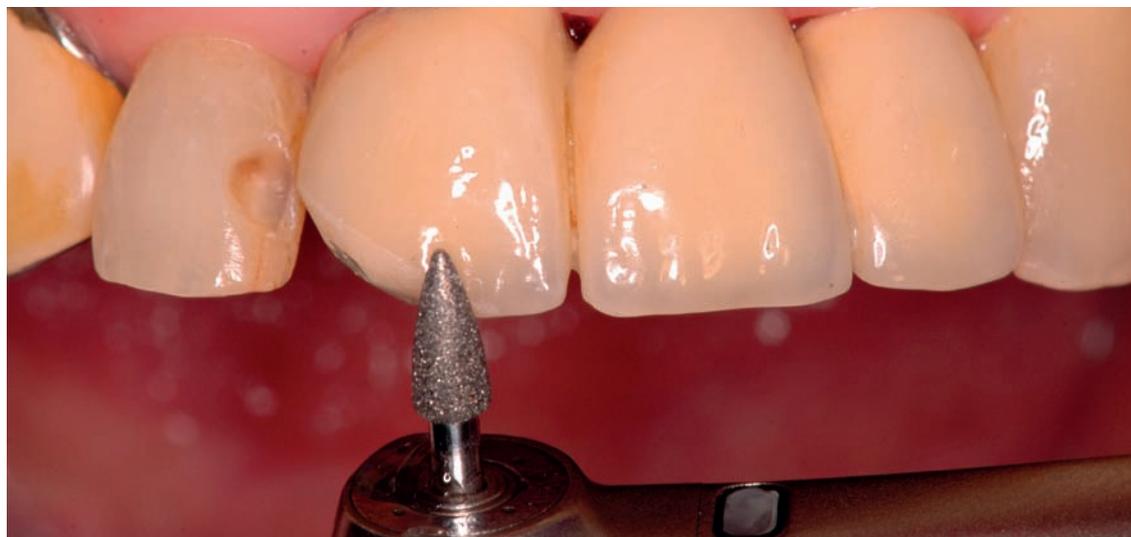
Figure 3: The fractured ceramic surface and areas adjacent to the defect zone were carefully roughened with a coarse diamond bur

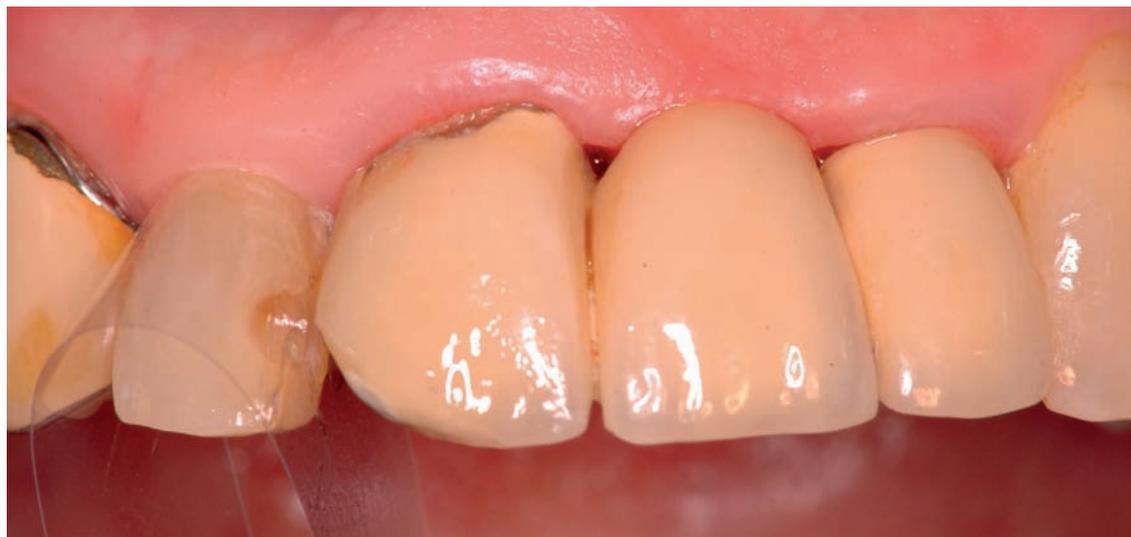
Figure 4: Bonding systems were applied to the areas to be restored, ie the fractured ceramic surface in tooth UR1 and the cavity surface in tooth UR2. Beautifil II LS is compatible with all common adhesive and ceramic/composite repair systems. The small metal surface exposed at the disto-incisal edge of the damaged crown was masked with dentine-coloured Beautifil Opaquer (UO)

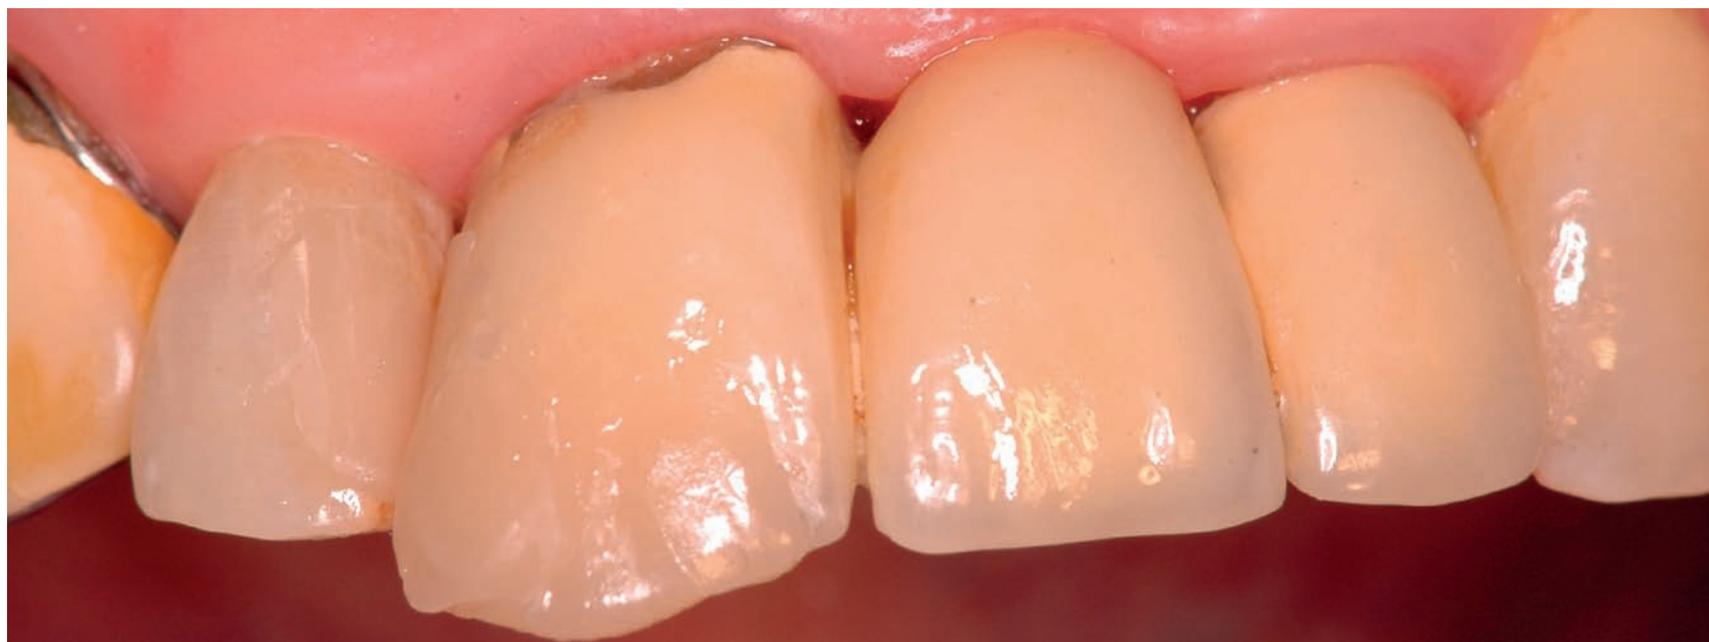
Figure 5: Both the small cavity and the large defect were restored using one monochromatic composite increment each (shade A3)

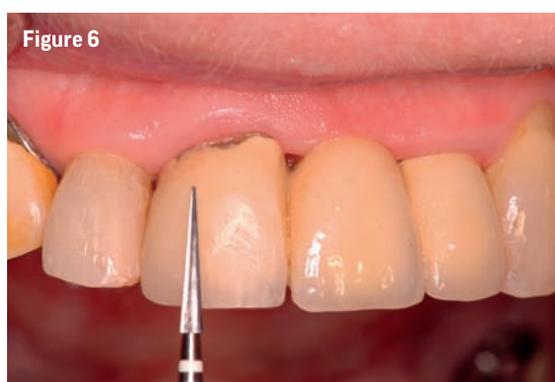
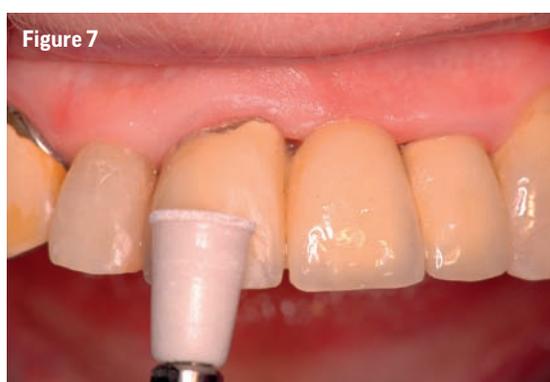
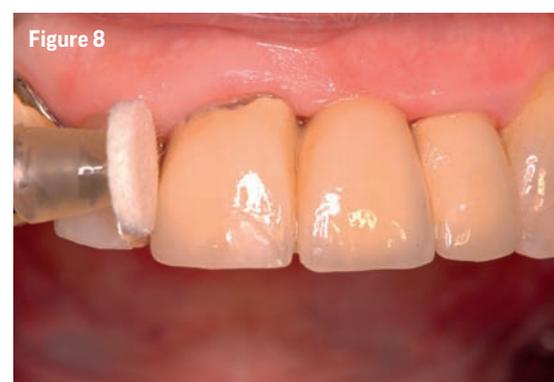
Figures 6-8: The direct restoration and the reconstructed disto-incisal edge of the ceramic veneer were successively contoured, finished, and polished to a high gloss, using carbide finishers, disposable silicone polishers with alumina (One-Gloss, Shofu) and a disposable felt disk impregnated with alumina polishing paste (Super-Snap Superbuff, Shofu)
