# Occlusal restoration of a molar – building up the correct occlusal anatomy directly from the syringe

## Clinical Case: Occlusal Restoration of a Molar (Class I)

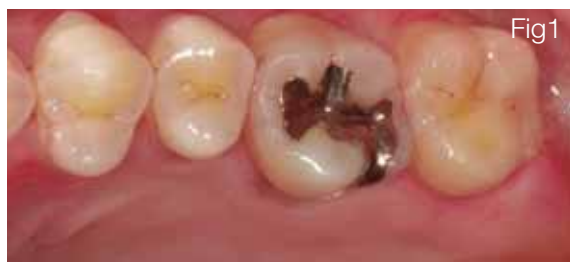
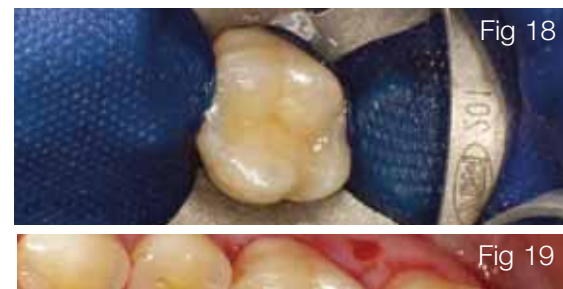
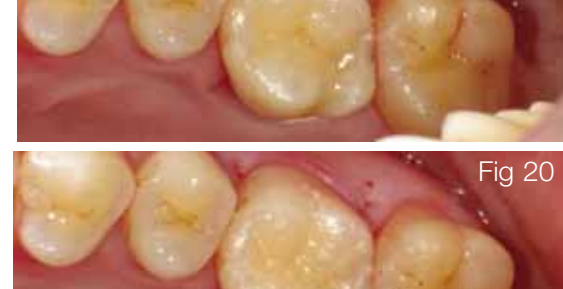
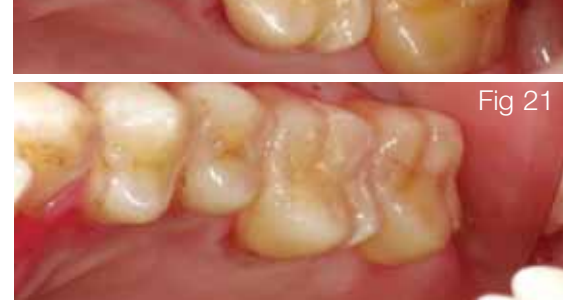
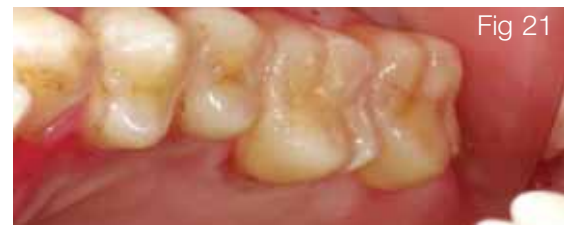
**Fig. 1:** Preoperative situation: The

occlusal surface of tooth 26 had been restored with a metal inlay. The patient complained that the restoration was not flush with the tooth when touching it with his tongue. Due to poor marginal integrity of the restoration and partial secondary caries, the patient was informed that the existing inlay needed to be replaced by a composite filling.

**Fig. 2:** After local anaesthesia, a rubber dam was placed. Since this case was an occlusal restoration, only the carious tooth was isolated.

**Fig. 3:** The metal inlay was removed. Then the palatal side of the affected dentin was excavated after applying a caries detection dye. Cavity preparation was completed.

**Fig. 4:** Bonding was performed with FL-Bond II (2-bottle self-etch system). First, the Primer was applied.

**Fig. 5:** The Primer was left undisturbed for 10 sec. and then air-dried to evaporate the solvents. When properly treated with the self-etch Primer, the surface is glossy after air-drying.

**Fig. 6:** Then the Bonding Agent of FL-Bond II was applied. As a Giomer product, it contains the S-PRG filler.

**Fig. 7:** After levelling the bond layer by air-blowing, it was sufficiently light-cured.

**Fig. 8:** Cavity surface after application of the Bonding Agent. The gloss has disappeared.

**Fig. 9:** BEAUTIFIL Flow Plus X F03 was applied to the cavity floor in one thin

layer. The purpose was to cover the cavity floor and round any line angles. Then the material was sufficiently light-cured.

**Fig. 10:** Application of F03 completed.

**Fig. 11:** The Cusps were created with F00. First, the palatal groove on the disto-palatal side was filled towards the palatal cusp. F00 was dispensed from the needle tip and slowly spread from the palatal side to the cusp. The desired shape was gently created with the tip of a probe. The material should not be manipulated too much, to avoid ruining the created shape. Then the material was light-cured for 3-5 sec. for stabilisation. Final light-curing would be performed later.

**Fig. 12:** Next, the mesio-palatal side of the palatal groove was filled. F00 was dispensed from the needle tip and slowly spread from the palatal side to the cusp. The material was moved towards the distal cusp light-cured in Fig 11 to create palatal grooves. Then it was light-cured for a few seconds.

**Fig. 13:** The disto-buccal cusp was created. The needle tip was positioned at the cusp margin, and the material was injected into the cavity while adjusting the amount. Filling should be stopped before the material reaches the central groove, and the applied material should be moved towards the central groove with a probe. After adjusting the contour, the material was light-cured.

**Fig. 14:** The mesio-buccal cusp was created like the disto-buccal cusp. The

amount of paste was adjusted, while confirming the central and buccal grooves. The applied paste was moved gradually with a probe, and the mesio-buccal cusp shape was created. When trying to obtain the desired shape with a probe, the material moved out of the intended position. Thus, the probe was used only to move the material, not to create shape. The material was light-cured for a few seconds.

**Fig. 15:** Then the mesio-palatal cusp was created in the same manner as the mesio-buccal cusp. The cusp size was adjusted while confirming the position of the central groove. And the material was light-cured for a few seconds.

**Fig. 16:** The mesial pit was created. The amount of paste needed to create the mesial pit and groove was adjusted. And again the material was light-cured for a few seconds.

**Fig. 17:** The distal pit was created in the same manner, then light-cured for a few seconds.

**Fig. 18:** The central groove appeared underfilled, so a small amount of F00 was added. Then final light-curing was performed sufficiently.

**Fig. 19:** Immediately after filling. The rubber dam was removed. Then, contouring and occlusal adjustment was performed with a superfine diamond point.

**Fig. 20 and 21:** Postoperative situation: Class I restoration with F03 and F00.
